② THIS IS HOW YOU SONIC

An intrepid cruiser looking for a bottom free of barnacles sets off to determine if an Ultrasonic sound-wave system provides true anti-fouling protection. BY WALLY MORAN

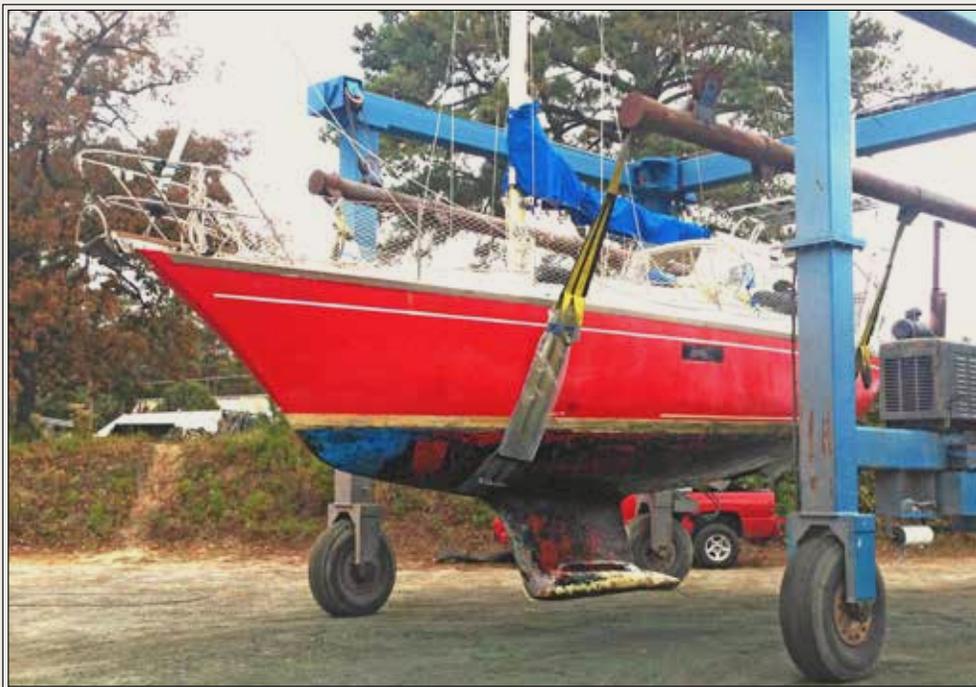
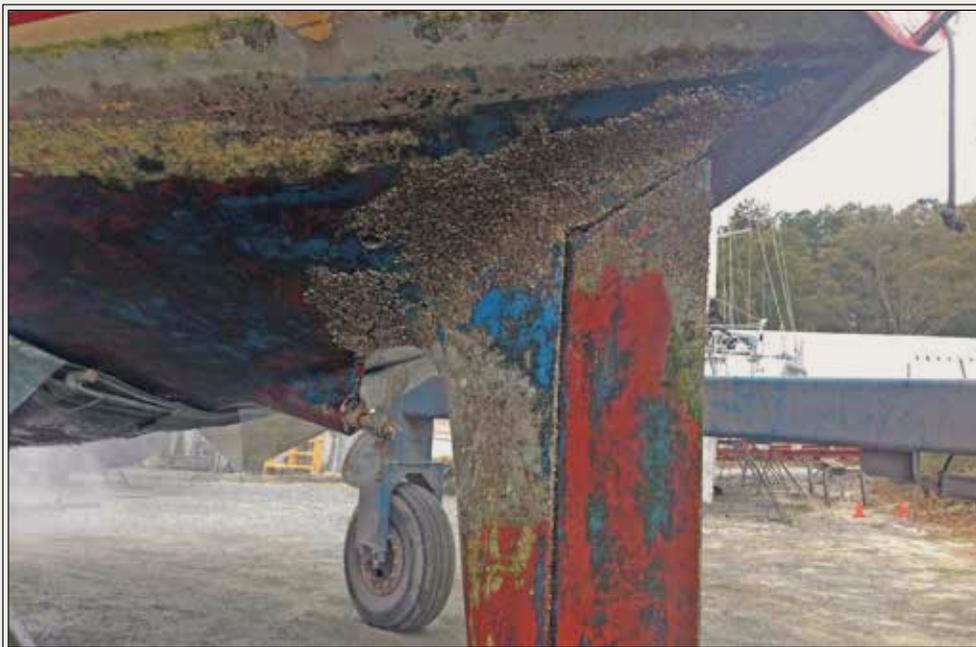
For close to a year, *Gypsy Wind* went without bottom paint, the only protection came from the Ultrasonic unit. Once hauled, the exposed layers of old bottom paint, offering no antifouling protection, were visible (top). The only significant area of barnacle growth after this extended period was near the skeg (bottom).

I ran the boat north back up the ICW in 2015 before hauling her out. Again, there was very little growth other than at the waterline, which is essentially out of the water and exposed to air, unprotected by the Ultrasonic unit. The only potential problem I've found

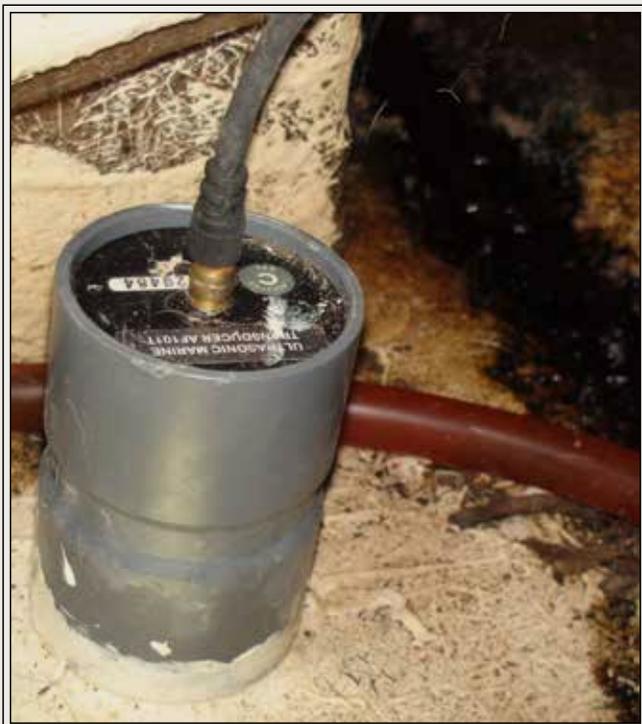
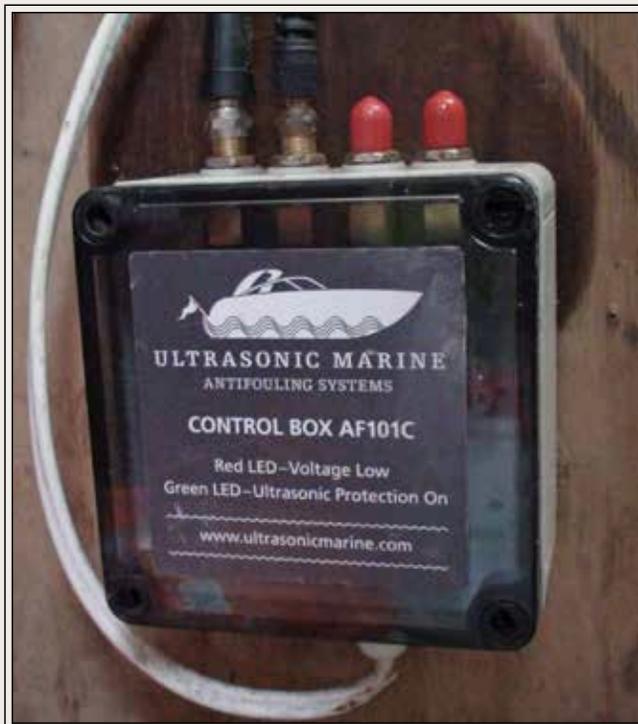
Aboard my 34-footer, *Gypsy Wind*, I installed a pair of transducers (left). Where you position them is critical to the effectiveness of the system. When installing, wriggle the unit into the epoxy to eliminate any air bubbles. The heart of the Ultrasonic system is the control box (right). Wiring is simple, with the power line clipped into the bottom of the unit, and the transducers into the top.

In the fall of 2014, I installed an Ultrasonic system sized for my 1975 Dufour 34, *Gypsy Wind*. The unit is comprised of a control box, two transducers, and the associated wiring connecting them. I epoxied the transducers directly to the hull per the instructions for my boat size, with one forward and another aft. The control box was placed close to the battery compartment to minimize wiring runs and reduce power loss to the transducers.

The basic wiring was quick and easy. The entire installation took no more than two hours, not including the setup time for the transducers' epoxy bedding. I mounted the transducers inside the boat, with one about 8 feet aft of the bow and the other in the engine room, slightly aft and to port of the keel. Placing one too close to the keel apparently interrupts the signal. Everything required was included — something more manufacturers need to do, as it saves on trips back to the store for the bits and pieces most of us invariably forget on any project.
